Thermographic inspection for building diagnosis

This work is the result of a thermography study of a residential building located on 119 Ferdinand Boulevard in Bucharest. This study was carried out at the request of the beneficiary because there were high energy consumption to achieve thermal comfort in the apartments.

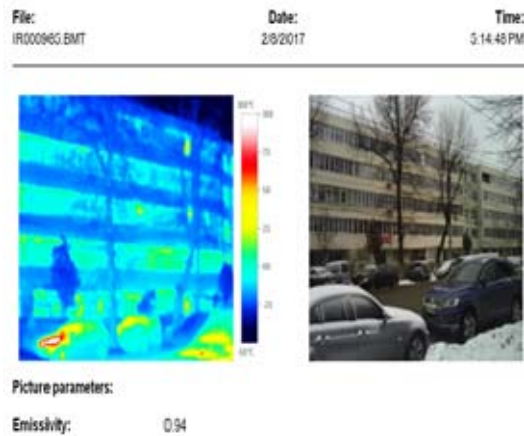
Fig. 1. South- east façade of the building

As we can clearly see in the both figures no. 1 and no. 2 there are some areas where the heat loss signature is increased due to some collateral facts that do not have anything in common with building insulation.

The red and yellow areas are due not to poor isolation, but rather to open windows to the kitchens, through which hot air is evacuated; as well as the use of a lower quality bottle when closing the balconies.

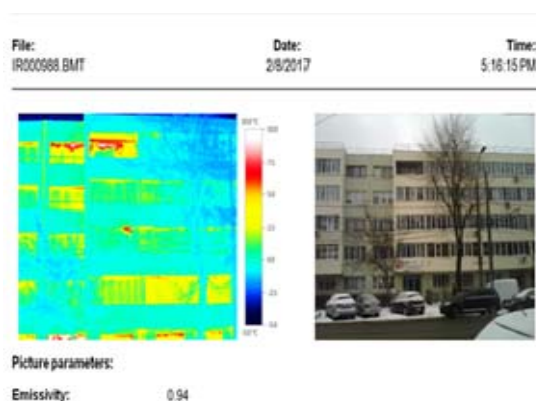
Fig. 3. South -east façade – last entrance

This method also helps in discovering hidden flaws that create an increased discomfort within the premises. Here, reference is made to non-insulated thermal bridges that can also generate dampness and insulation cracks that can cause a continuous cold feeling.

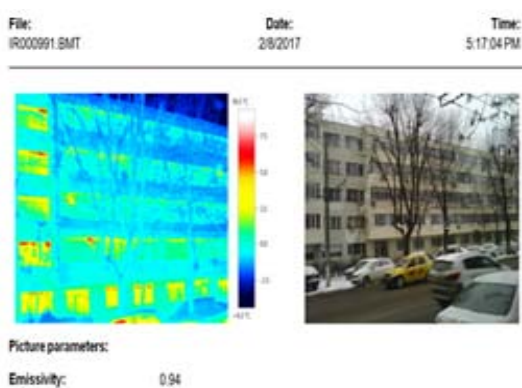
Fig. 5. East corner view

This thermography is done only externally to determine the potential loss through the building envelope. Figure no. 5 is one of the most expressive, within it being noticed, how much the thickness of insulation, its quality and the quality of glass matters.

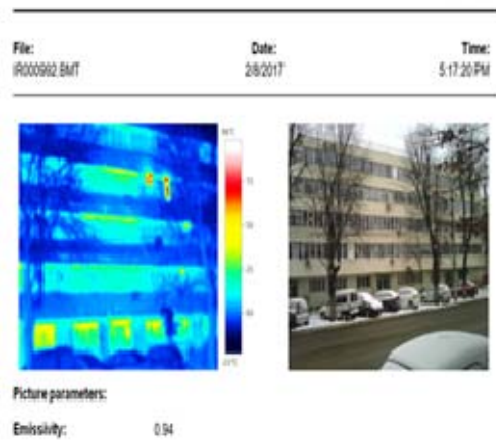
Fig. 6. Caption of the Figure 1. Below the figure

In figure no. 6 there is a large loss of heat through the windows on the ground floor. It is clear that the balcony is not warmed up properly and there is a risk that the mold will appear at the top.

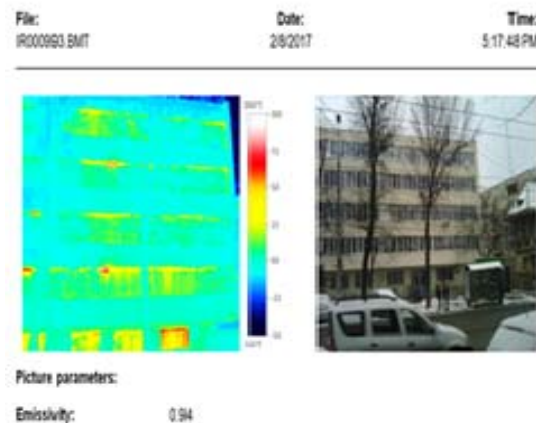
Fig. 7. View of the west end.

The next step in determining heat loss is the actual calculation. A check can be made if the insulation is the right one or should be thicker. The following figures show how to isolate the corner of a building. There is a more pronounced yellow to red color area, an area that is an open window. There is a pronounced blue area. This is the air temperature in the area.

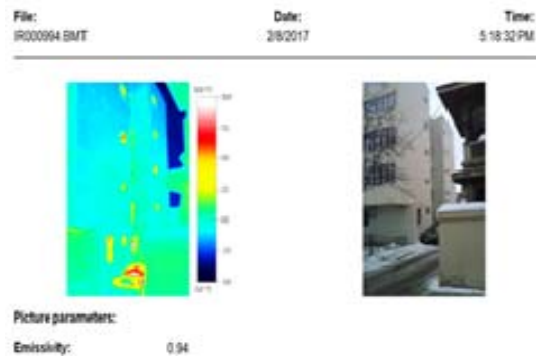
Fig. 8. West corner view of the building

The windows have some general features present in most of the records. Frames and window frames represent a thermal bridge with a difference of about 2-3 degrees Celsius. This is why in the upper part there is a slightly higher temperature than the rest, which should not be interpreted as a thermal bridge.
