# New method of increasing building efficiency

The objective of this paper is to review the current state and to identify the future challenges regarding the application of thermography in building heat loss calculation. This paper is a result of a study over two buildings, one residential home situated in Constanta and a bloc of apartments from Bucharest. We carried out those two studies at the request of the inhabitants in order to detect why the thermal comfort is so low. All the tests were done using a professional thermal imaging camera, Testo 885-2.

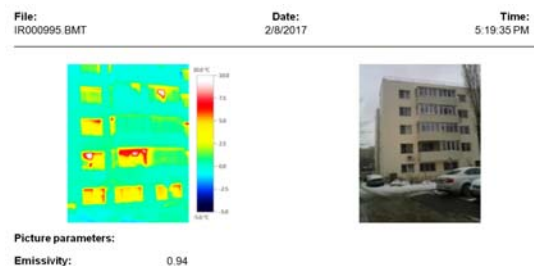
Fig. 1. North side of the building

Figures 1, 4 and 5 are very conclusive about the way the insulation was made for the apartments bloc. The blue colour from the facades means that the temperature on the exterior surface of the insulation is very close to the exterior temperature leading us to the idea that thickness was well-chosen.

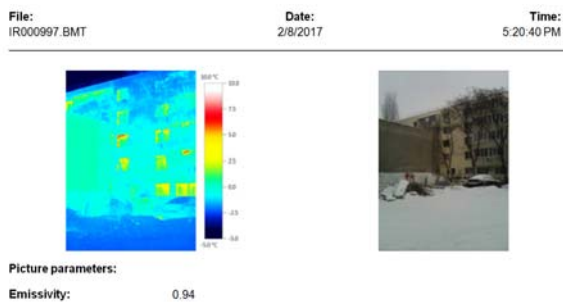
Fig. 3. South side of the building

In both cases, the colour palette of the thermal chamber was set so as to highlight differences of up to 1.5 degrees Celsius. As is shown in figure 3, the red spots are not thermal bridges but open windows from balconies.

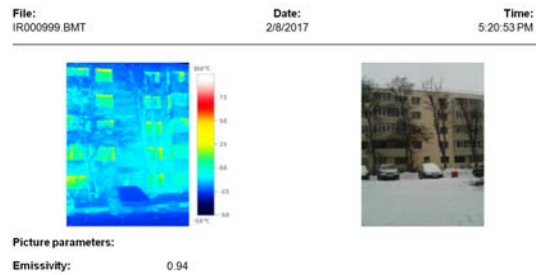
Fig. 5. South side- different angle

At the same time there is no heat loss at the joints of the polystyrene boards, which indicates that the commissioning was done well. One thing notable is the quality of the windows, in both cases studied. These are new generators with at least two sheets of glass. The last image of the building represents the east side of it and we can observe some small differences regarding heat transfer through elements of glass (yellow colour). It is clear that the balconies are not properly heated and the risk of mold to appear at the top of the interior walls high.
