Thermographic inspection for building diagnosis

This work is the result of a thermography study of a residential building located on 119 Ferdinand Boulevard in Bucharest. This study was carried out at the request of the beneficiary because there were high energy consumption to achieve thermal comfort in the apartments.

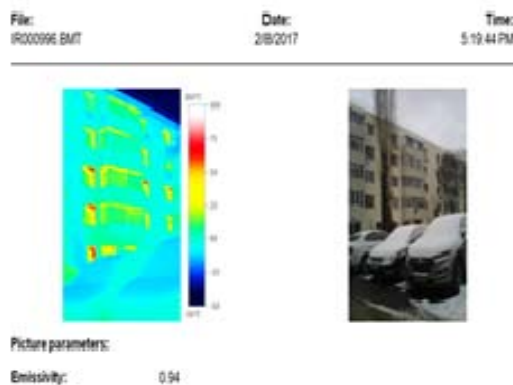
Fig. 9. View along east side of the building

The windows have some general features present in most of the records. Frames and window frames represent a thermal bridge with a difference of about 2-3 degrees Celsius. This is why in the upper part there is a slightly higher temperature than the rest, which should not be interpreted as a thermal bridge.
