Intruziunile de rădăcini în conductele de canalizare

Root intrusions in sewer pipes.

Teodor Valeriu Chira¹

DOI: 10.37789/rjce.2022.13.1.11

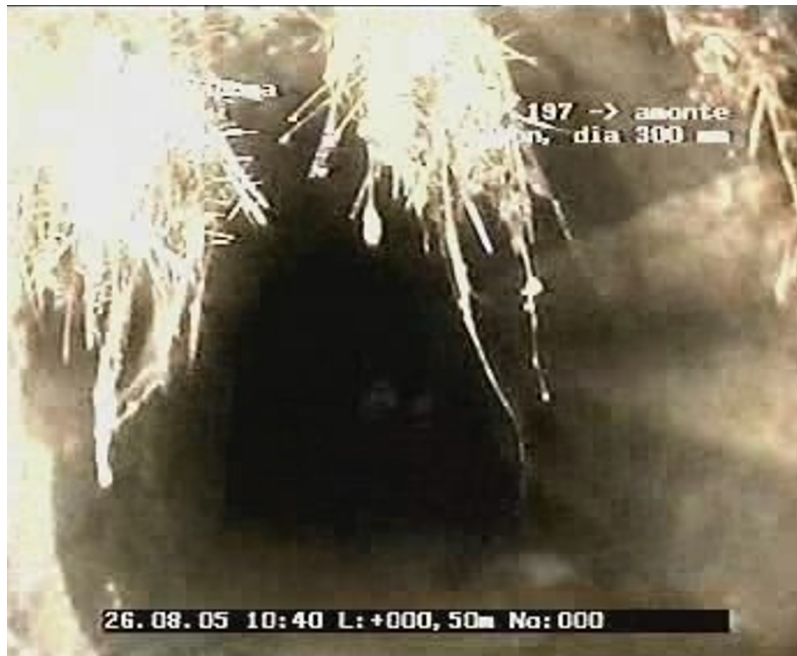
Fig. 1. Root intrusions in concrete sewer pipe [1], [2].
The roots are starting to branch already.

From Table 1 it can be observed that faults presented in the first two lines of the table are singular cases of root intrusions but the rest of 7 instances are all on the same sewer section, on Mălinului street. In this case some ornamental trees are planted along the sewer pipe path, and three of these trees have their roots in the sewer pipe. It can be observed that first two faults are close together, the roots belonging to the first tree, the second group of two faults are close – the roots belong to the second tree and the last three faults are close one of another – the roots belong to the third tree.

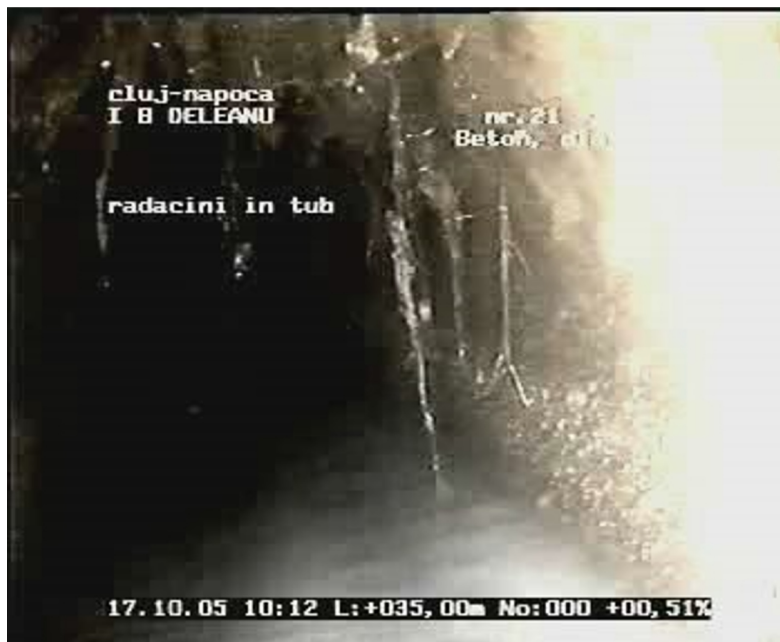
Fig. 2. Root intrusions in concrete sewer pipe [1], [2].
In this case the fault is in a more incipient state, the roots are long but not as branched out as in the previous image.

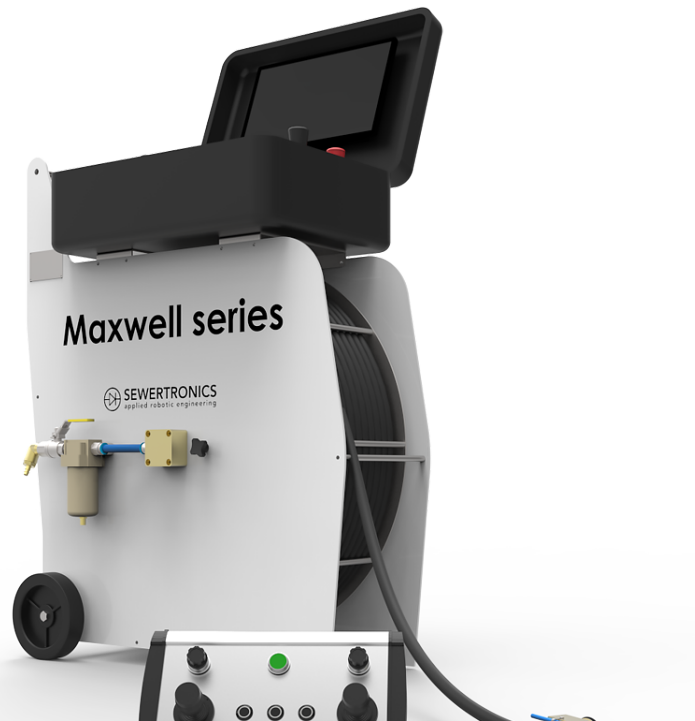
Fig. 3. Maxwell 250 - robot for cutting roots inside pipes from DN100 to DN250[3]

What can it be done in case root intrusions are found in the sewer pipe? It depends on severity of the fault. The first step would be to remove de roots by cutting them with special tools. In this respect there are available several types of cutting heads that can be fitted on robots like those used for CCTV inspection. Figure 3 and 4 present such equipment. These robots are also useful in implementation of some rehabilitation techniques like CIPP – Cured In Place Pipe. For this reason, we can observe in figure 3 a connection for compressed air.

These robots have a pretty narrow domain of diameters in which they can work, for example Maxwell 250, as the name implies, goes up to 250mm. Maxwell 400, presented in figure 4, goes only up to 400mm and so on.

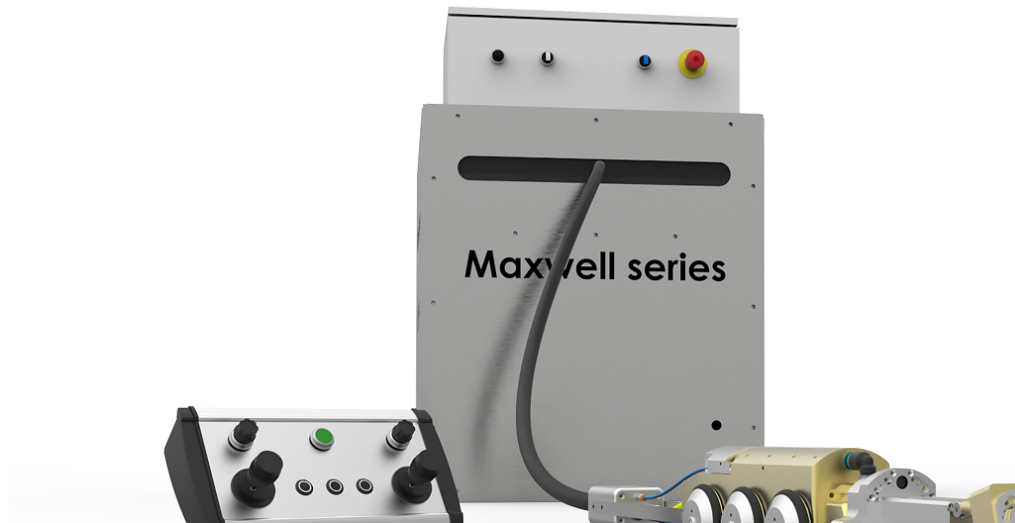
Fig. 4. Maxwell 400 - robot for cutting roots inside pipes from DN150 to DN400[3]

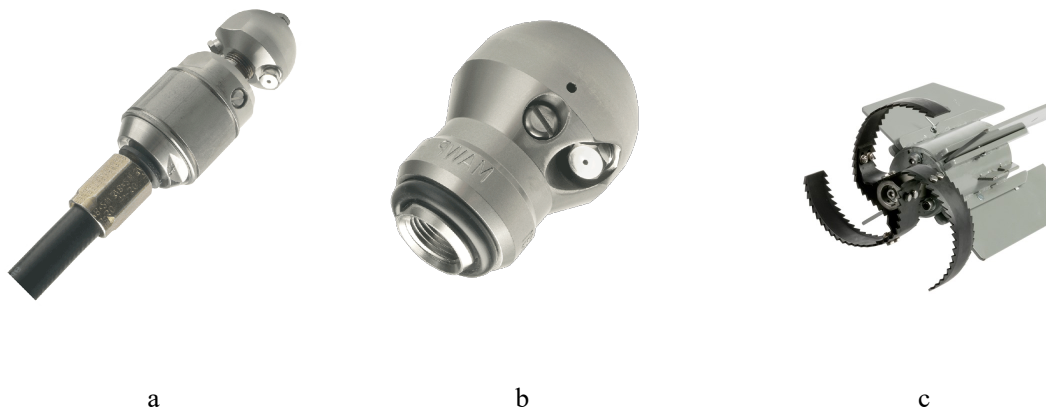
Fig. 5. Examples of jetting nozzles. [4]
a – Warthog jetting nozzle small 1/2" (50-75 lpm) with cutting head;
b – Warthog Mini 1/2" jetting nozzle (45-80 lpm); c – hydraulic rootcutter

Another option would be to use the pressure of the water to do the cutting. In this respect there are available special designed cutting nozzles. These jetting heads work well in smaller diameter pipes. For example, Warthog jetting nozzle is available for different sizes and flows of water, please see figure 5.

The first example in figure 5 requires a flow of water of 50 to 75 liters per minute and the second example requires 45 to 80 liters per minute. There are other kinds of cutters using the pressure of water, like the Hydraulic Rootcutter [4]. This is using the water pressure to rotate a head with serrated curved blades, much like a saw blade. Using any of these heads will result in a quantity of debris consisting of small fragments of roots which must be washed away from the pipe.
